Underside Deck Testing of Iron Woods[™] Brand Ipe Hardwood Material

Indicative testing conducted in accordance with the test methodology described in CSFM 12-7A-4, Materials and Construction Materials for Exterior Wildfire Exposure: Decking

WFCi Report #12158r1

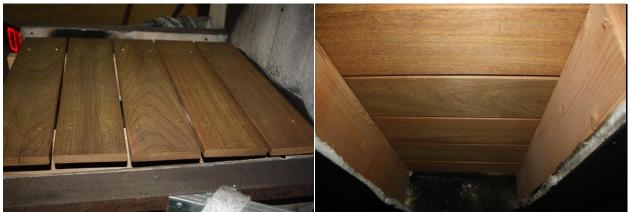
The ipe hardwood material was received by WFCi on December 17, 2012 and January 3, 2013 as 2' planks. WFCi did not verify the manufacturing techniques or accuracy of the products and labeling. No third-party sampling was performed or verified for this product. Each plank was $\frac{3}{4}$ " $\times 5\frac{1}{2}$ " $\times 24$ " (square-edge). Five boards were positioned on two nominally 2×6 Douglas fir joists, 28¼" long with 16" center-to-center spacing. The edge-to-edge spacing of the planks was maintained at $\frac{3}{16}$ ", resulting in a top deck surface area of 4.7 ft². The test planks were attached to the joists with deck screws. The moisture content of the planks and joists were approximately 11% at the time of testing, as measured by oven-drying.

Figure 3. Representative test assembly for under deck tests.

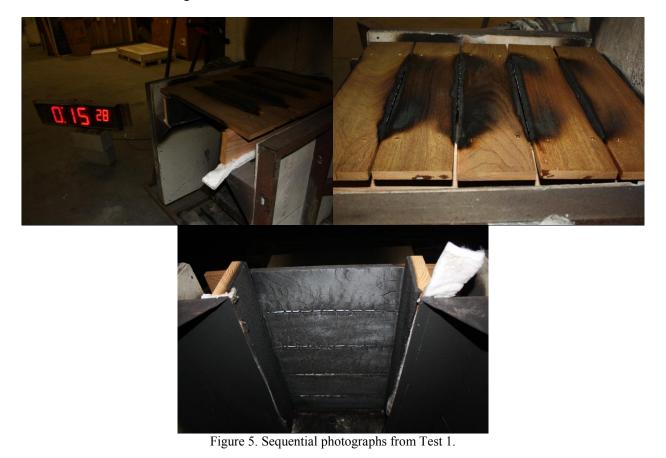
A typical test exhibited flaming within the deck gaps within 1-2 minutes during burning application. Once the burner was turned off, flames continued in the gaps for approximately 1 minute. Glowing continued for another 3-5 minutes, while smoking continued for 10-15 minutes following the burner being turned off, after which the test was terminated.

Figure 6. Sequential photographs from Test 2.

Under deck testing of the assemblies took place on January 16, 2013. The energy from the burner was verified before testing took place to be 78.3 ± 1.5 kW. All three assemblies displayed heat release below the criterion of 25 kW/ft² as can be seen in Table 1 and Figure 4, no continued combustion (flaming, glowing, or smoking) after the 40 minute observation period, and no particles that continued to burn once hitting the floor or burner. Photographs are also included in Figure 5 - Figure 7.

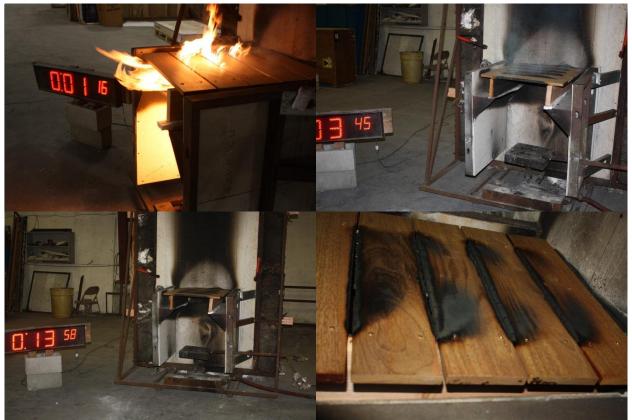
Figure 7. Sequential photographs from Test 3.

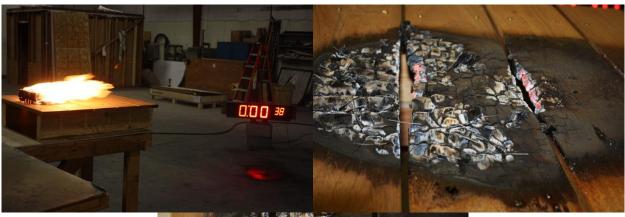
A typical test exhibited flaming within the deck gaps within 1-3 minutes after brand application. The brand continued to burn for approximately 10-15 minutes on top of the deck assembly. Glowing typically continued in the gaps for another 10-15 minutes, until it was self-extinguished. Once combustion ceased, the test was terminated.

Figure 8. Sequential photographs from Test 4.

Burning brand testing of the assemblies took place on January 18, 2013. The wind speed was verified before testing took place to be 5.28 ± 0.8 m/s. All three boards maintained structural stability and did not continue to burn (flaming, glowing, or smoking) after the 40 minute observation period and no particles continued to burn once hitting the floor. Photographs are also included in Figure 8 - Figure 10.

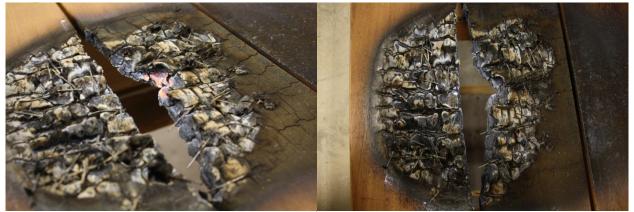
Figure 9. Sequential photographs from Test 5.
